## FRENCH BAY HOUSE - CASE STUDY

January 2019

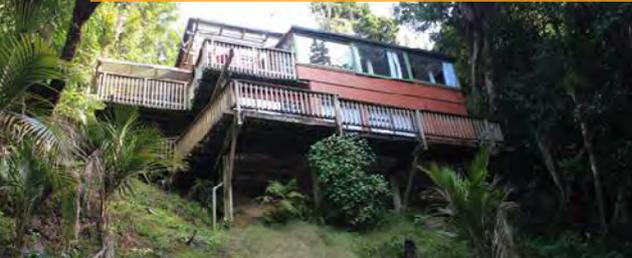
The French Bay House is a 'typical' Titirangi home, a unique cabin style infrastructure situated on a steep slope. The challenges created by this type of construction are the large spaces between the floor and the ground, which create significant draughts in windy conditions and the exposed gabled roof, which reduces the insulation choices. In addition, the floor and ceiling joists were not evenly spaced and in the roof, they were often greater than 700mm apart. The owners of the French Bay House, Ryan and Deidre, already painstakingly completed insulating part of the house with polystyrene and so when they were selecting insulation for the remainder of the home it was important that it would be easy to install.

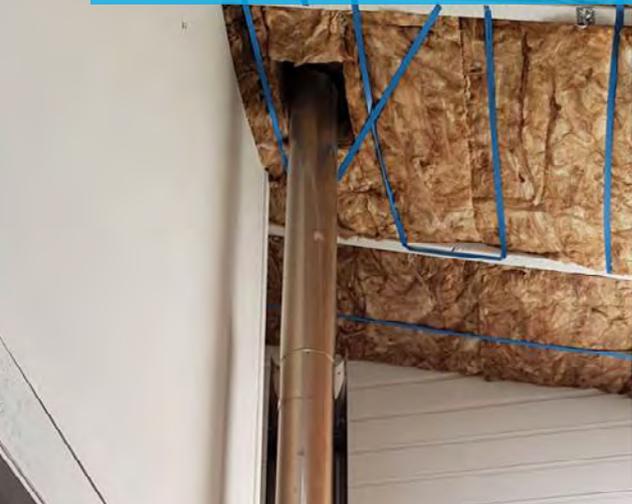
Earthwool® glasswool insulation: Ceiling batt, R4.1 was installed in the ceiling, providing the owners with excellent thermal performance. The rigidity of the ceiling batts also meant they could be turned sideways and friction fitted between joists that were greater than 580mm.

Earthwool® glasswool insulation: Underfloor roll with a wind-wash barrier, R1.8, was installed towards the outer edges of the floor, while Earthwool® glasswool insulation: Quilted underfloor batt, R1.5 was used towards the back of the house where the space was a little tighter to work.

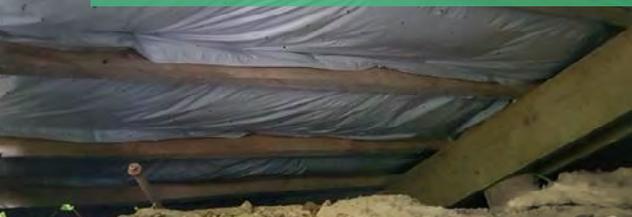
"Having already painstakingly completed one portion of our home with polystyrene underfloor insulation, it was so nice to finally work with Earthwool® glasswool insulation, as it was soft to touch, easy to cut and install and eliminated the issues we had previously with the polystyrene," said Ryan.
